TECHNICAL REVIEW

No.22 / September 2024

Technical Review
MAPNA TURBINE ENGINEERING & MANUFACTURING CO. (TUGA)

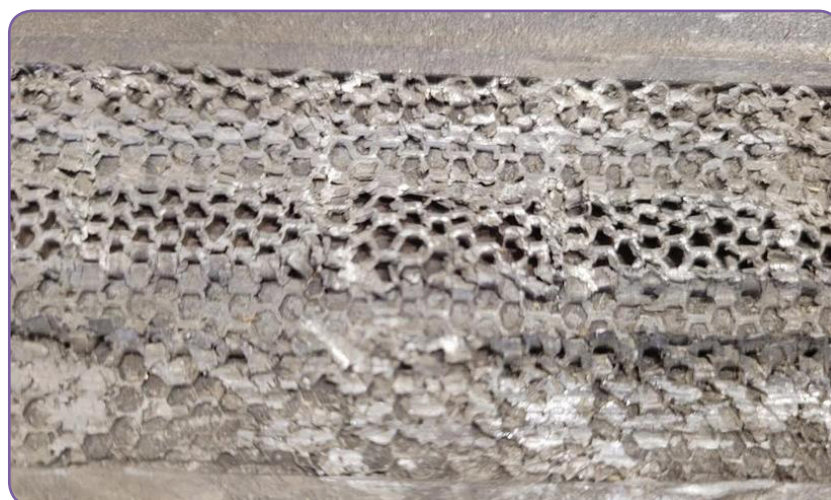
Figure 3 - Honeycomb seal area on a 2nd stage nozzle vane of MGT-30 after first overhaul duration

It is necessary to mention that the 2nd stage nozzle vanes have honeycomb seals which were damaged due to their operation. Figure 3 shows an example of such damaged seals. Due to severe damage to the honeycomb seals, they were removed by machining to be replaced with new ones in the repair process.

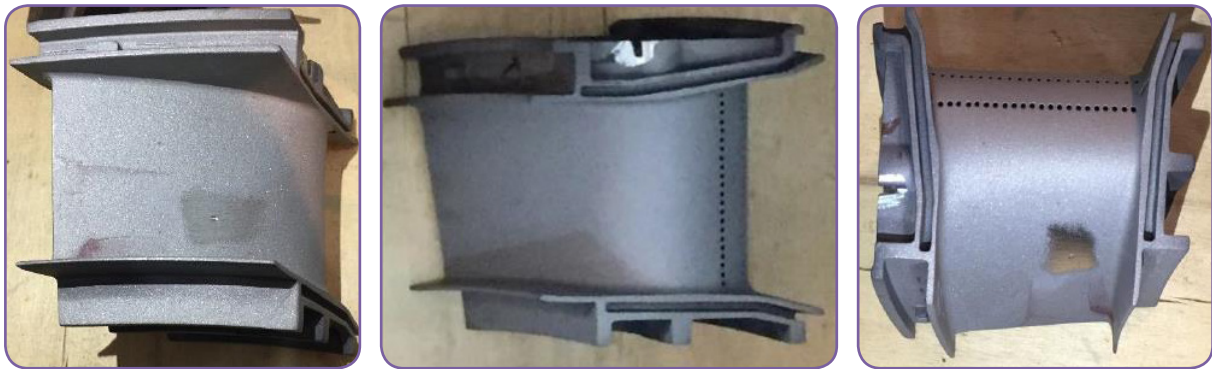
Figure 4 - A 1st stage nozzle vane of MGT-30 after defect removal by grinding

All identified defects were removed by grinding and other proper methods and then inspected using FPI again in order to ensure that defects were completely removed. Figure 4 shows the 1st stage nozzle vane of MGT-30 after defect removal by grinding.

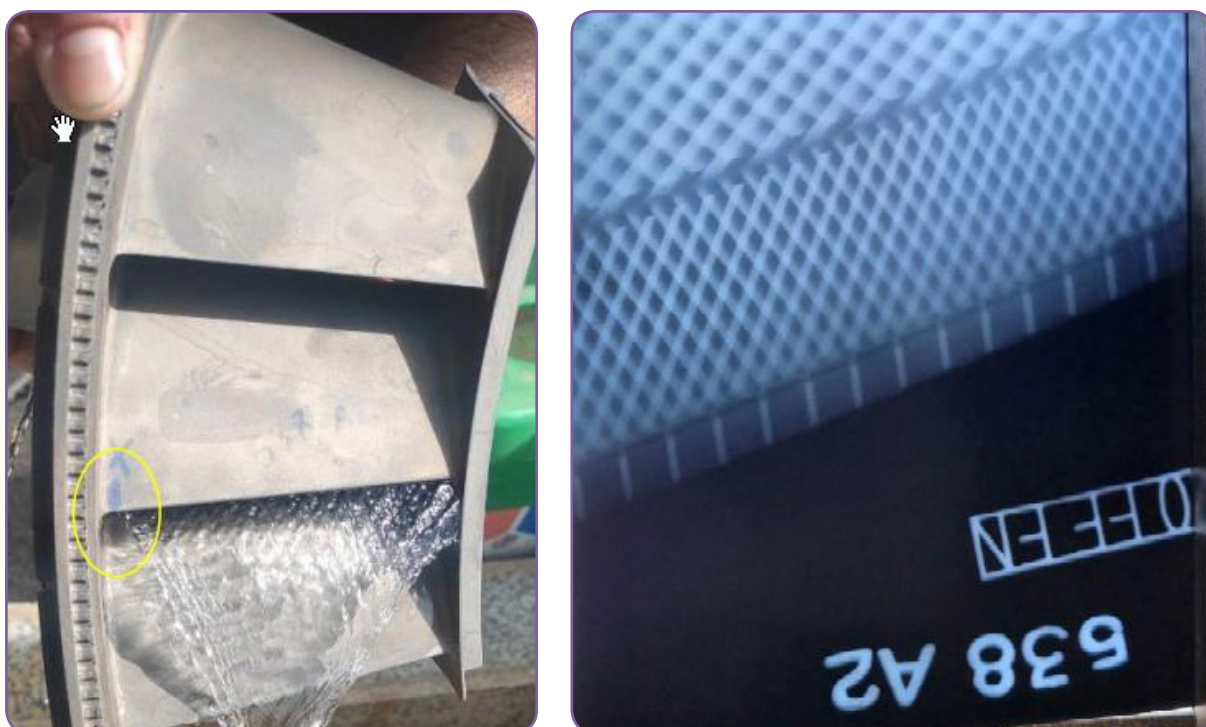
Figure 10 - Examination of the cooling flow path for 2nd stage nozzle vane using water flow test and radiographic testing (RT)

In addition to inspecting the aforementioned geometrical features and dimensions, air and water flow tests through the cooling passages and vane holes are crucial during the repair process and life extension of the hot section nozzle vanes of a gas turbine. Insufficient flow can lead to inadequate cooling, while excessive flow can affect overall turbine performance. Any blockages, geometrical restrictions, or imbalances can result in uneven cooling and potential hot spots. Conducting air and water flow tests helps ensure the effectiveness of the cooling system and prevents the vane from overheating. In this case, all vanes were installed in a customized test stand to measure the flow rate, ensuring design requirements (Figure 10). Additionally, water flow tests were conducted for all the vanes undergoing repair and life extension, to ensure that the cooling medium is evenly distributed across all holes of a vane.

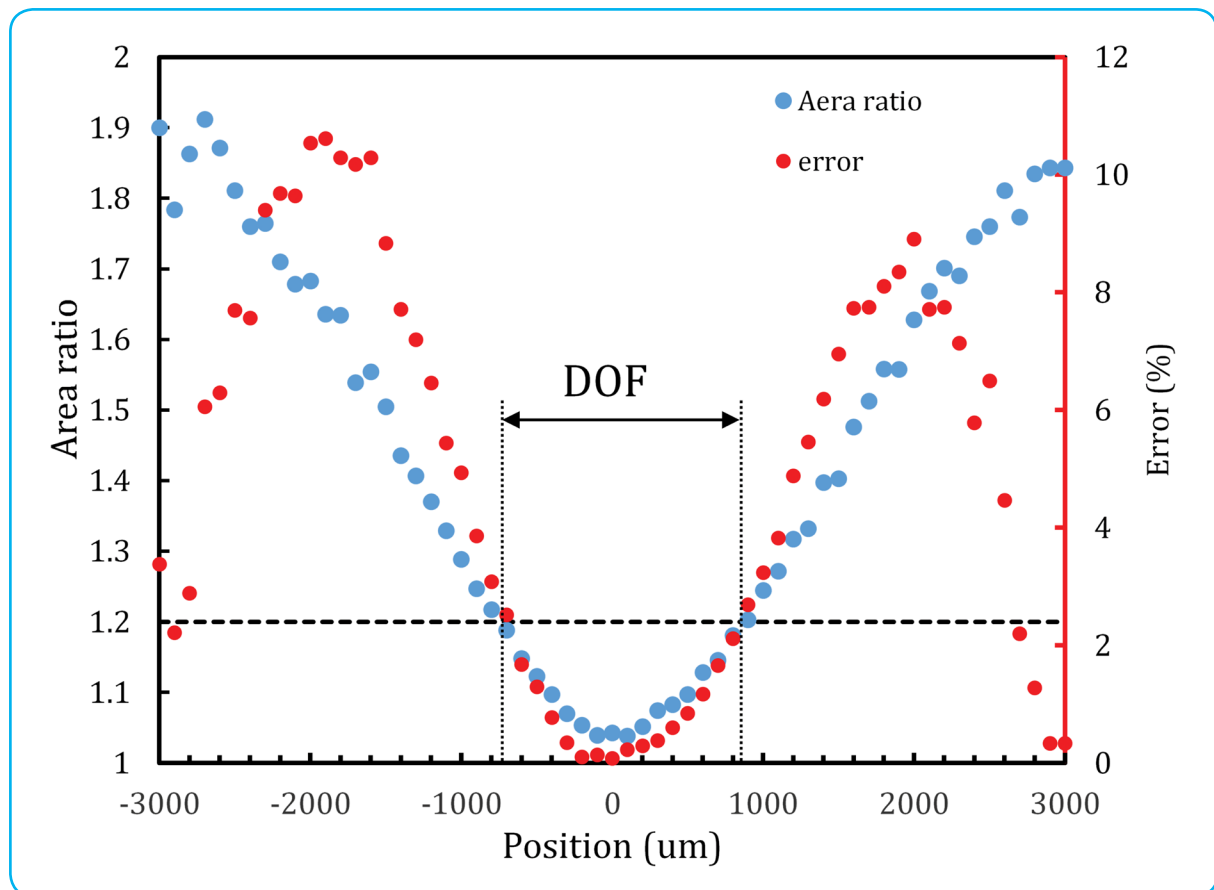
Figure 4 - Changes in the area ratio of the lower and upper threshold and the corresponding error according to the distance of the calibration slide from the focal plane (Full circle diameter: 254 microns, Upper threshold: 70%, Lower threshold: 52%)

Figure 4 depicts variations in the area ratio alongside the error of the equivalent diameter calculation through equation (1), against the distance of the calibration slide from the focal plane for a complete circle with a 254-micron diameter. This Figure shows that the sharpest state is achieved at the focus plane, which corresponds to the lowest area ratio. As the distance from the focus plane increases, both the area ratio and the corresponding error experience almost linear increment on both sides. This observed trend of changes in the area ratio and error validates the viability of the model for accepting out-of-focus droplets detected in real images. Considering an area ratio acceptance limit of 1.2, the maximum error resulting from measuring a full circle with a 254-micron diameter is about 3%, which is a highly favorable value.

The calibration process involves the evaluation of all full circles on the calibration slide. After conducting a comprehensive analysis of all the collected data, it has been determined that by setting the upper, lower, and global threshold values to 62, 70, and 52, respectively, and additionally selecting an area ratio limit of 1.2 to accept out-of-focus droplets, the maximum error resulting from post-processing remains below 5%.

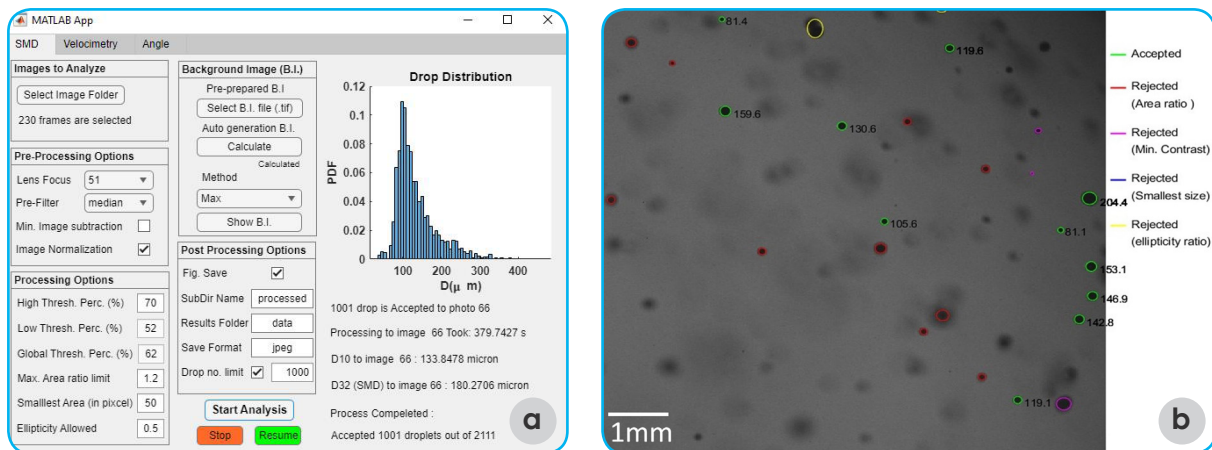
Figure 6 - a) Spray Droplets Analysis software, b) The post-processed image of Figure 10(b)

To assess the software configurations and potential adjustments, an additional feature enables the preservation of post-processed images. The post-processed image depicted in Figure 6(b) corresponds to Figure 5(b). Specifically, only the droplets contained within colored circles are identified, and among these droplets, only those surrounded by green circles meet the criteria of area ratio, minimum area, and ellipticity filters. Consequently, the green circles are considered for the droplet diameter distribution.
